Technical product information

Transmission: clutch pedal clacks

Transaction No.: 2018689/1

Release date: 25-Sep-2008

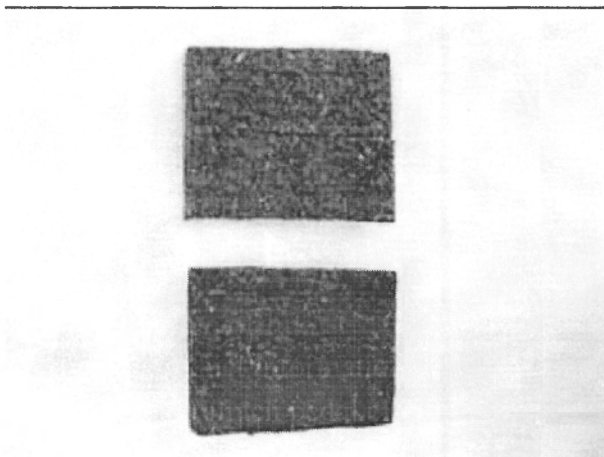
Noises (clacking) when operating clutch

Conflicting tolerance between pressure drawbar mounting and pressure drawbar of clutch master cylinder.

Cut 2 pieces of felt (part number: 533 867 910 A).

Length: 16mm

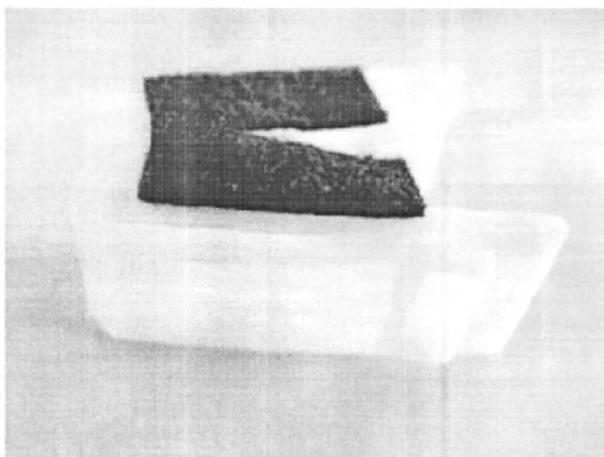
Illustration shows relaxed condition

bond the felt at 7mm distance on the pressed-together mounting.

Replace the treated mounting on the clutch pedal according to the repair manual.
